AERO TWIN, INC.

SERVICE BULLETIN

ATI S.B. No. 01-02

Auxiliary Dry Air Pump Kit N0. AP8-100 STC SA4626NM Wiring Modification

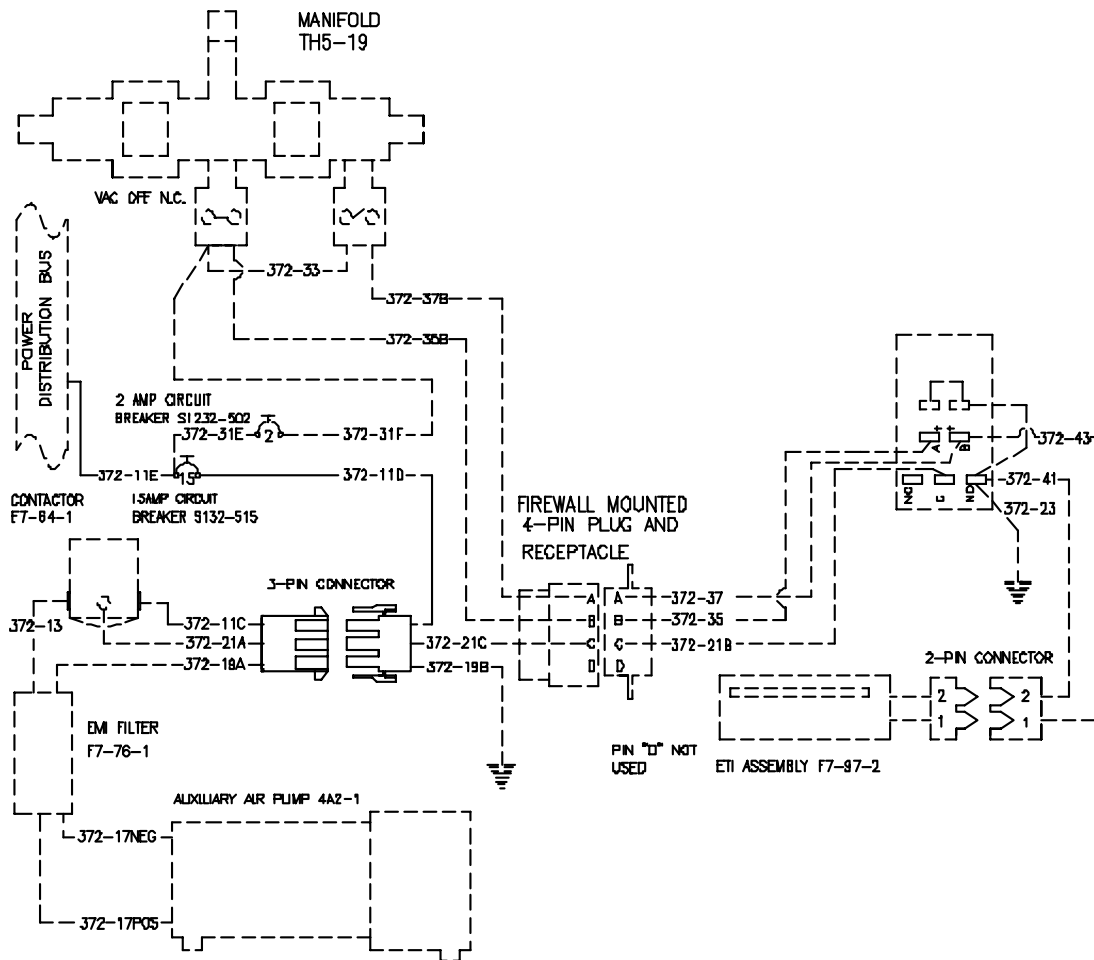
An STC review has shown the need for replacement of inadequate size wires supplying power to the Auxiliary Dry Air Pump. No failures have been reported, but this modification is needed to insure an adequate level of safety exists for aircraft utilizing this optional equipment.

- 1) Remove the old 18 gauge wire (has red terminal ends) number 372-11E from the "15 AMP CIRCUIT BREAKER" and discard. (See attached schematic)
- 2) Install replacement 16 gauge wire (has blue terminal ends) number 372-11E to the same locations.

- 3) Remove and discard the old 18 gauge wire (has red terminal ends) number 372-11D running between the "15 AMP CIRCUIT BREAKER" and the "3-PIN CONNECTOR"

- 5) Install replacement 16 gauge wire (has blue terminal ends) number 372-11D running between the "15 AMP CIRCUIT BREAKER" and the "3-PIN CONNECTOR".
- 6) Complete Section 1.2 "Operational Check-Engine Off" from the Instructions for Continued Airworthiness Document, Number AP8-ICA.
